Home Inspection Report

646 Johnson Dr, Carmel, IN 46033

Tuesday, April 7, 2015

040715

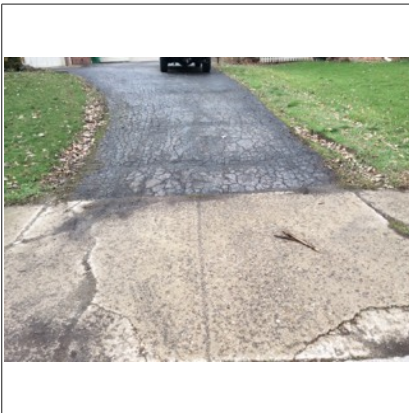
Driveway/Parking

☐ None ☐ Not Visible
Material ☐ Concrete ☒ Asphalt ☐ Gravel/Dirt ☐ Brick ☐ Other
Condition ☐ Satisfactory ☒ Marginal ☐ Poor ☐ Settling Cracks ☐ Typical cracks ☐ Pitched towards home
☐ Trip hazard ☐ Fill cracks and seal

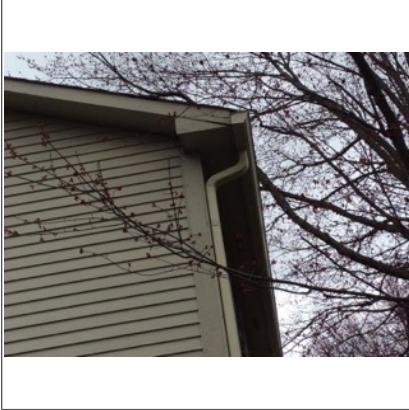
Negative Grade ☐ East ☐ West ☐ North ☐ South ☒ Satisfactory ☐ Recommend additional backfill
☐ Recommend window wells/covers ☒ Trim back trees/shrubberies
☐ Wood in contact with/improper clearance to soil

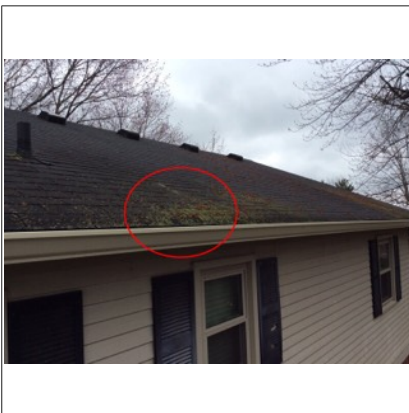
Roof #1 ☐ Satisfactory ☒ Marginal ☐ Poor ☐ Curling ☐ Cracking ☐ Ponding ☐ Burn Spots
☐ Broken/Loose Tiles/Shingles ☐ Nail popping ☐ Granules missing ☐ Alligating ☐ Blistering
☐ Missing Tabs/Shingles/Tiles ☒ Moss buildup ☐ Exposed felt ☐ Cupping
☐ Incomplete/Improper Nailing ☐ Recommend roofer evaluate ☐ Evidence of Leakage
Roof #2 ☐ N/A ☒ Satisfactory ☐ Marginal ☐ Poor ☐ Curling ☐ Cracking ☐ Ponding ☐ Burn Spots
☐ Broken/Loose Tiles/Shingles ☐ Nail popping ☐ Granules missing ☐ Alligating ☐ Blistering
☐ Missing Tabs/Shingles/Tiles ☐ Moss buildup ☐ Exposed felt ☐ Cupping
☐ Incomplete/Improper Nailing ☐ Recommend roofer evaluate ☐ Evidence of Leakage
Roof #3 ☐ N/A ☒ Satisfactory ☐ Marginal ☐ Poor ☐ Curling ☐ Cracking ☐ Ponding ☐ Burn Spots
☐ Broken/Loose Tiles/Shingles ☐ Nail popping ☐ Granules missing ☐ Alligating ☐ Blistering
☐ Missing Tabs/Shingles/Tiles ☐ Moss buildup ☐ Exposed felt ☐ Cupping
☐ Incomplete/Improper Nailing ☐ Recommend roofer evaluate ☐ Evidence of Leakage

Comments Recommend cleaning moss and mold off of the roof.
Photos

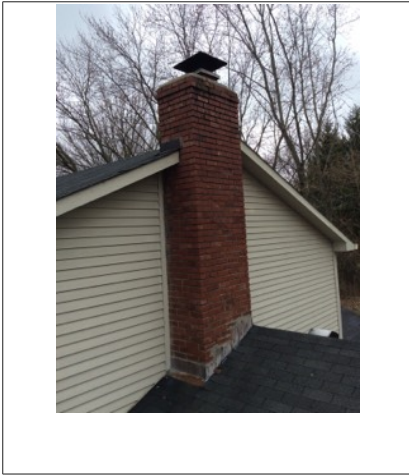
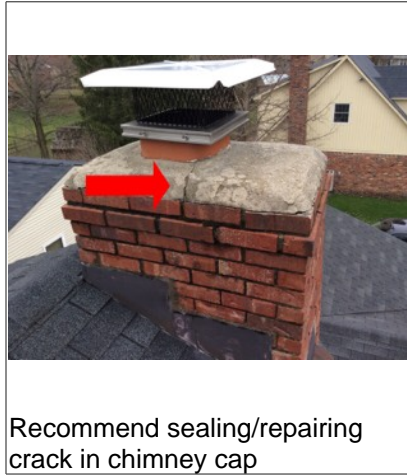
Evidence of ☐ Holes in metal ☒ Cracked chimney cap ☐ Loose mortar joints ☒ Flaking ☐ Loose brick ☐ Rust
☐ No apparent defects

Evidence of ☐ Scaling ☐ Cracks ☐ Creosote ☒ Not evaluated ☒ Have flue(s) cleaned and re-evaluated
☐ Recommend Cricket/Saddle/Flashing ☐ No apparent defects

Comments Chimney flue was not evaluated.

Recommend sealing/repairing crack in chimney cap

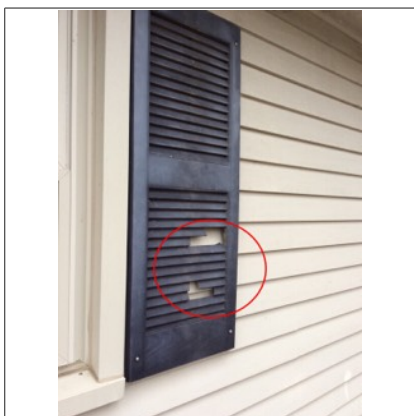
Comments Recommend repairing broken shutter on 2 nd floor east window

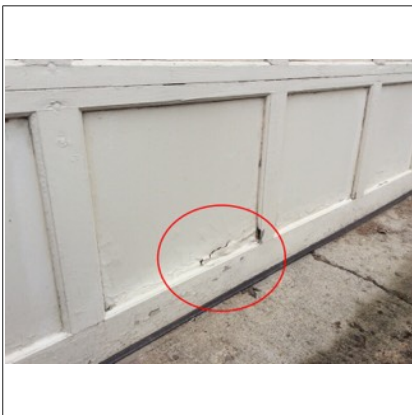
☐ N/A
Material ☒ Wood ☐ Fiberglass ☐ Masonite ☐ Metal ☐ Recommend repair
Condition ☐ Satisfactory ☒ Marginal ☐ Poor ☐ Hardware loose ☐ Safety Cable Recommended
☐ Weatherstripping missing/damaged ☐ Loose/missing
Recommend Priming/Painting Inside & Edges ☒ Yes ☐ No
Comments Recommend repair/replace wood rot on overhead door. See photo
Photos
