Home Inspection Report

646 Johnson Dr, Carmel, IN 46033

Tuesday, April 7, 2015

040715

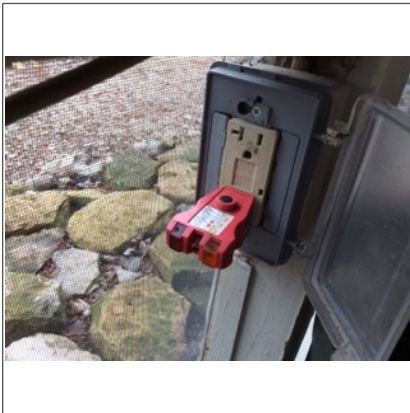
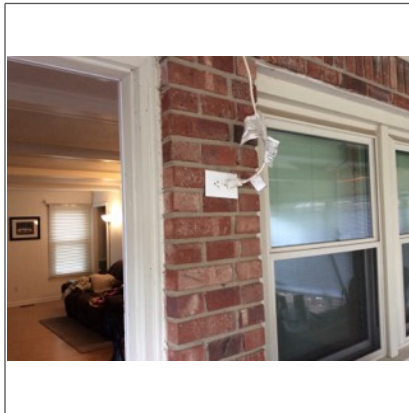
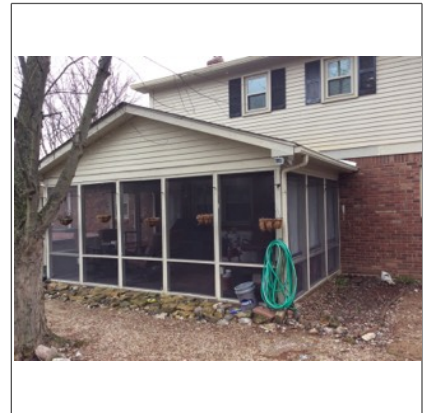
**Patio**

- Material** ☐ None ☒ Concrete ☐ Flagstone ☐ Kool-Deck ☒ Brick ☐ brick paver on concrete
- Condition** ☒ Satisfactory ☐ Marginal ☐ Poor ☐ Settling cracks ☐ Trip hazard
- ☐ Pitched towards home (see remarks) ☐ Drainage provided ☐ Typical cracks
- Comments** SW GFCI receptacle has no power.
Receptacle on exterior brick wall has no power. Recommend repair and should be GFCI protected.
Recommend replacing light switch operated wall receptacle with light. See photo

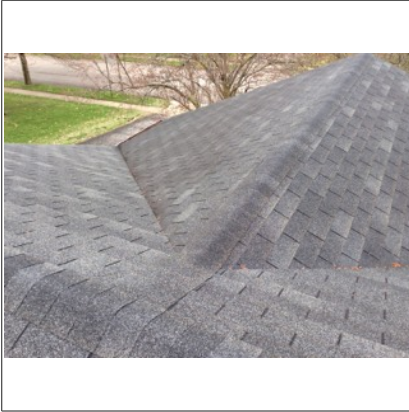
Condition of Roof Coverings

Roof #1 ☐ Satisfactory ☒ Marginal ☐ Poor ☐ Curling ☐ Cracking ☐ Ponding ☐ Burn Spots
☐ Broken/Loose Tiles/Shingles ☐ Nail popping ☐ Granules missing ☐ Alligating ☐ Blistering
☐ Missing Tabs/Shingles/Tiles ☒ Moss buildup ☐ Exposed felt ☐ Cupping
☐ Incomplete/Improper Nailing ☐ Recommend roofer evaluate ☐ Evidence of Leakage
Roof #2 ☐ N/A ☒ Satisfactory ☐ Marginal ☐ Poor ☐ Curling ☐ Cracking ☐ Ponding ☐ Burn Spots
☐ Broken/Loose Tiles/Shingles ☐ Nail popping ☐ Granules missing ☐ Alligating ☐ Blistering
☐ Missing Tabs/Shingles/Tiles ☐ Moss buildup ☐ Exposed felt ☐ Cupping
☐ Incomplete/Improper Nailing ☐ Recommend roofer evaluate ☐ Evidence of Leakage
Roof #3 ☐ N/A ☒ Satisfactory ☐ Marginal ☐ Poor ☐ Curling ☐ Cracking ☐ Ponding ☐ Burn Spots
☐ Broken/Loose Tiles/Shingles ☐ Nail popping ☐ Granules missing ☐ Alligating ☐ Blistering
☐ Missing Tabs/Shingles/Tiles ☐ Moss buildup ☐ Exposed felt ☐ Cupping
☐ Incomplete/Improper Nailing ☐ Recommend roofer evaluate ☐ Evidence of Leakage

Comments Recommend cleaning moss and mold off of the roof.
Photos

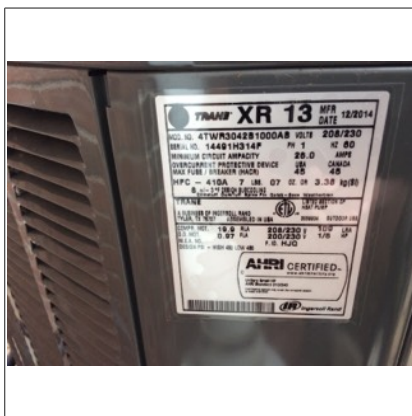
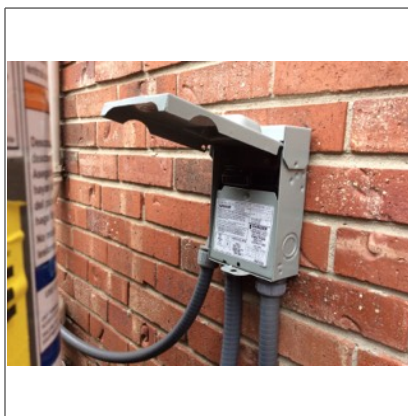
Unit #1 ☐ N/A
Location:
Exterior rear wall
Brand:
Trane
Model #:
4TWR3042B1000AB
Serial #: 14491H314F
Approximate Age:
Mfr date 12/2014
Condition ☒ Satisfactory ☐ Marginal ☐ Poor ☐ Cabinet/housing rusted
Energy source ☒ Electric ☐ Gas ☐ Other
Unit type ☒ Air cooled ☐ Water cooled ☐ Geothermal ☐ Heat pump
Outside Disconnect ☒ Yes ☐ No Maximum fuse/breaker rating (amps): 45 Fuses/Breakers installed (amps): 50
☒ Improperly sized fuses/breakers
Level ☒ Yes ☐ No ☐ Recommend re-level unit
Condenser Fins ☐ Damaged ☐ Need cleaning ☐ Damaged base/pad ☐ Damaged Refrigerant Line ☒ Satisfactory
Insulation ☐ Yes ☒ No ☐ Replace
Improper Clearance (air flow) ☐ Yes ☒ No
Comments

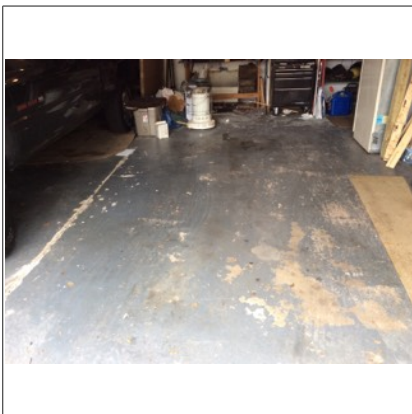
☒ Concrete ☐ Gravel ☐ Asphalt ☐ Dirt ☐ Other
☒ Satisfactory ☒ Typical cracks ☐ Large settling cracks ☐ Recommend evaluation/repair
☐ Safety hazard
 Source of Ignition within 18" of the floor ☐ N/A ☐ Yes ☒ No
Comments

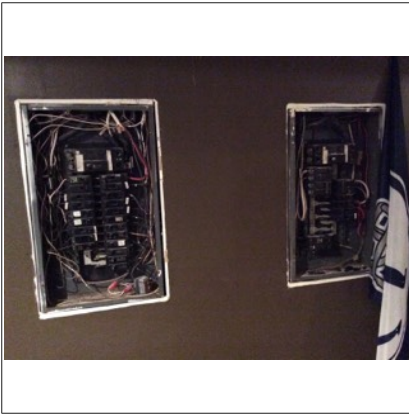
Location Basement
Condition ☒ Satisfactory ☐ Poor
Adequate Clearance to Panel ☒ Yes ☐ No
Amperage/Voltage ☐ Unknown ☐ 60a ☐ 100a ☐ 150a ☒ 200a ☐ 400a ☐ 120v/240v
Breakers/Fuses ☒ Breakers ☐ Fuses
Appears grounded ☒ Yes ☐ No ☐ Not Visible
GFCI breaker ☐ Yes ☒ No Operable: ☐ Yes ☐ No
AFCI breaker ☐ Yes ☒ No Operable: ☐ Yes ☐ No ☐ Not Tested
Main wire ☐ Copper ☒ Aluminum ☐ Not Visible ☐ Double tapping of the main wire
 Condition: ☒ Satisfactory ☐ Marginal ☐ Poor
Branch wire ☒ Copper ☐ Aluminum ☒ Solid Branch Aluminum Wiring ☐ Not Visible ☐ Safety Hazard
Branch wire condition ☒ Satisfactory ☐ Poor ☐ Recommend electrician evaluate/repair ☒ Romex ☐ BX cable
☐ Conduit ☐ Knob/Tube ☐ Double tapping ☐ Wires undersized/oversized breaker/fuse
☐ Panel not accessible ☐ Not evaluated
 Reason:
Comments Branch breaker distribution appeared normal.
 No signs of overheating were evident at the time of the inspection.
 Outlets were randomly tested and had correct polarity, except as noted.
